Stress Corrosion Cracking of HVOF Coated and Cr Plated AerMet 100 Steel

E. U. Lee, H. C. Sanders and S. Hartle
Naval Air Warfare Center Aircraft Division
Patuxent River, MD 20670

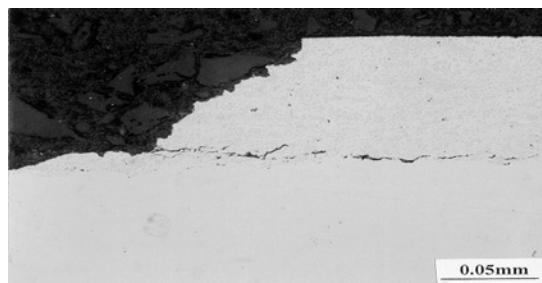
Figure 8. Cross-Section of HVOF Coated Buttonhead Round Rod Specimen.

As Polished

Polished & Etched

interface through plating cracks and flakes. Furthermore, the galvanic corrosion is believed to accelerate the subsequent initiation and growth of a stress corrosion crack in the base metal. Figure 8 shows a cross-section of a HVOF coated buttonhead round rod specimen. Similar flaking of coating and corrosion pits on the interface of base metal are seen. Figure 9 shows a cross-section of a HVOF coated square bar specimen. Cracking and flaking of coating, and cracking from the corroded interface into the base metal are observable. The crack path is mostly intergranular, branching and deflecting, typical of SCC, as shown in Figure 10.
